VALLEY VIEW LAKE DAM

NDI ID No. PA-01006  
DER ID No. 19-75

PHASE I INSPECTION REPORT

11 FEBRUARY 1981

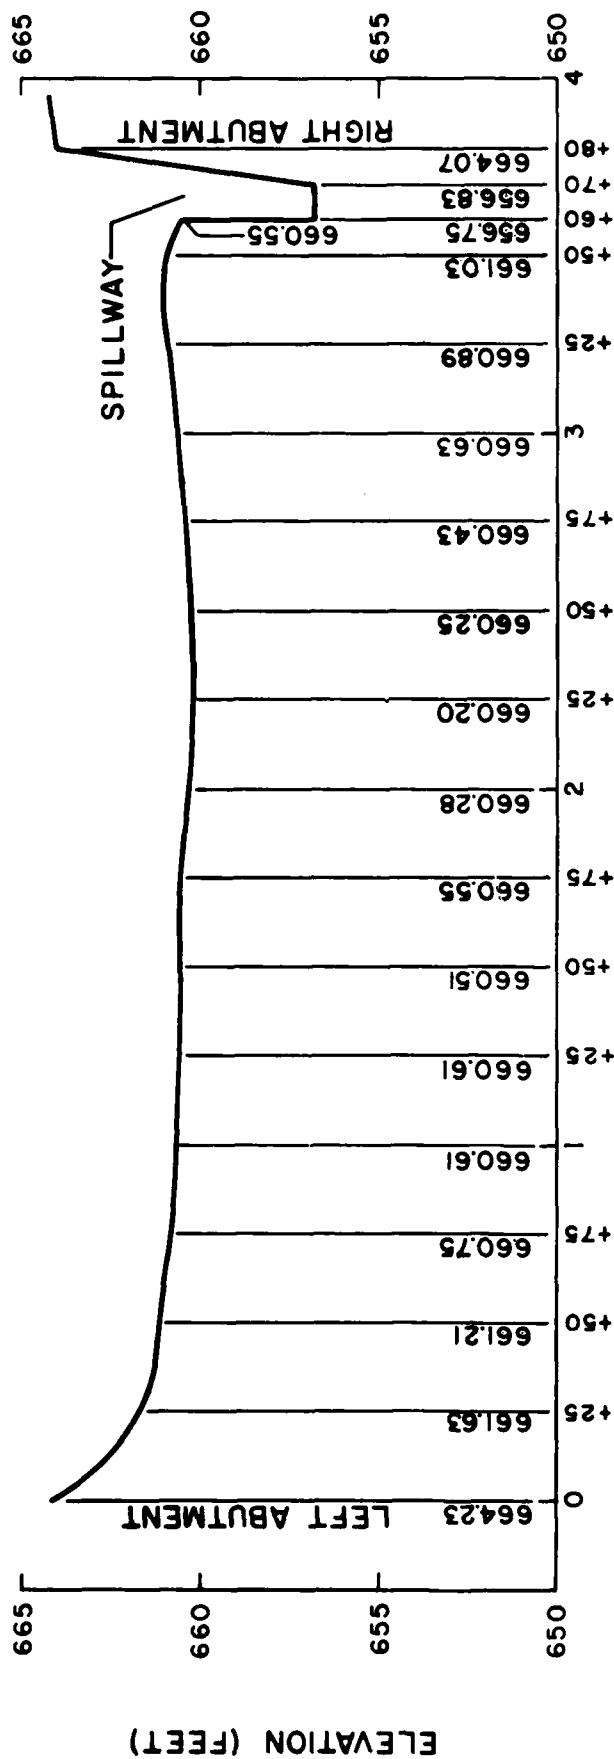
EXHIBIT A-1

b. Embankment. The horizontal alignment of the dam is good; however a crack, about 40 feet long, is forming on the downstream face near the left abutment. The junction of the dam and left downstream abutment form a drainage channel which is eroding and causing the adjacent embankment to slough sufficiently to form the crack. A large clump of briars is growing upslope of the crack. The downstream face and the upper 18 inches of the upstream face are grass covered. The crest, which is used as a roadway, and the remainder of the upstream face are covered with small gravel and shale bedding respectively. Trees and brush are growing along the downstream abutment contacts. Clear seepage is flowing at the rate of about 8 gpm from two locations at the toe between the midpoint of the dam and the left abutment contact. The source is unknown but may be springs since the lake is reported to be spring-fed. The vertical alignment of the crest is fair, with a maximum variation of 0.7 feet; however the low point which is located at the dam's right center is one foot below the design crest elevation of 661.25.
